Unmanned aerial vehicle acquisition of three-dimensional digital image correlation measurements for structural health monitoring of bridges

Daniel Reagan, Alessandro Sabato, Christopher Niezrecki*
University of Massachusetts Lowell, 1 University Avenue, Lowell, MA, USA 01852

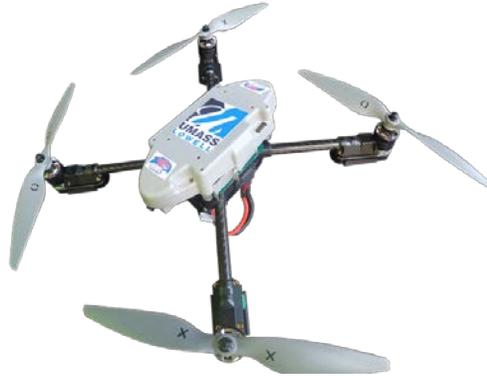
Figure 1. InstantEye Gen4 heavy lift variant developed by Physical Science, Inc. (PSI).

The DIC sensor system design is based on the specifications of the selected UAV: the InstantEye Gen4 heavy lift variant developed by Physical Science, Inc. (PSI) having a theoretical payload limit of 2.25 kg. The DIC system selected consists of a pair of 2 Megapixels acA1600-20um digital cameras manufactured by Basler employing a $(7.16 \times 5.44) \cdot 10^{-3}$ m interline progressive charge coupled device (CCD) monochrome image sensors with a resolution of 1626×1236 pixels and a pixel size of $(4.4 \times 4.4) \cdot 10^{-6}$ m. The cameras were fitted with 8.5 mm focal length lenses manufactured by Edmund Optics Ltd. The 3D-DIC system was positioned to have a working distance of 1.75 meter and a cameras separation distance of 0.707 m, which resulted in a 25° separation angle between the cameras' central line of sight. The decision to use this working distance depends on the fact that the developed DIC payload was intended to work in parallel with a synthetic aperture radar (SAR) sensor module having an ideal working distance of 1.75 m²⁹. In this configuration, the stereo-photogrammetry system was capable of measuring an area of 1.414×1.075 m. Furthermore, the payload is equipped with a Minnowboard-MAX, runs a Linux-based OS, and uses on an ad-hoc Wi-Fi network for connection with a remote laptop. This feature allows an operator to remotely control the two cameras for adjusting the camera parameters and taking the pictures. Figures 1 and 2 show the InstantEye Gen4 heavy lift variant quad-copter and the customized 3D-DIC payload used in the tests described in this research.

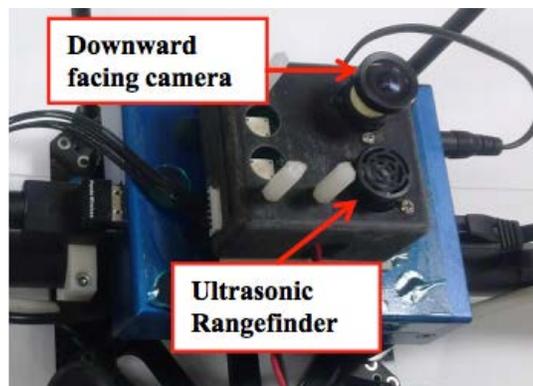
Figure 3. Sonar based optical vertical position hold module.

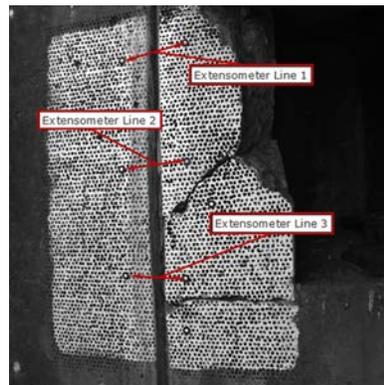
Figure 5. Monitoring area and extensometer locations across the expansion joint.

The first area examined is located on the left side of the bridge as shown in Figure 4, nearly 5 meters away from the road level. This area is difficult to access without proper equipment and this characteristic makes even more evident the utility of performing optically based measurements with the support of UAV technologies. As can be observed from Figure 5, the area of interest is located across the expansion joint and it also possesses two large (~ 2 -5mm) horizontal cracks.

This research focuses on demonstrating the efficiency of the 3D-DIC UAV system in measuring the displacement of the joint. Therefore, data was collected by measuring the changes in relative position between optical targets placed across the expansion joint only. The center of each optical target is a measurement point that can be thought of as the edge of an extensometer. The position of these points is tracked through each of the successive acquired images and their 3D coordinates are calculated with sub-pixel accuracy. Flight inspections of the joint widths were performed on three dates (May 11th, 2016; June 23rd, 2016; and October 18th, 2016) in a setup similar to that shown in Figure 6. Figure 7 shows the averaged extensometer displacement results from multiple 3D point tracking measurements. In particular, five snapshots for each of the individual measurements performed were taken to allow data averaging during post-processing analyses and to verify measurement repeatability. The results presented in Figure 7, show the displacement of the joint calculated as the average of the displacements characterizing the three extensometers during each of the individual measurements performed. Moreover, the error bars shown in the same figure represent the standard deviation range for five measurements taken at each of the three extensometer lines. Analyzing the trend of the displacement plotted in Figure 7, it is possible to observe a contraction in the joint during the transition from spring to summer followed by an expansion during the transition from summer into fall. It is assumed that these displacements result from the thermal expansion and contraction of the concrete abutments.

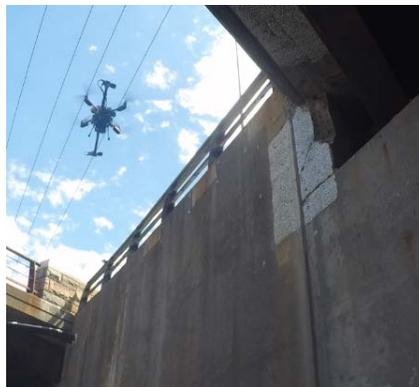
Figure 6. UAV inspection being performed at the expansion joint on the bridge's abutment wall on June 23, 2016.

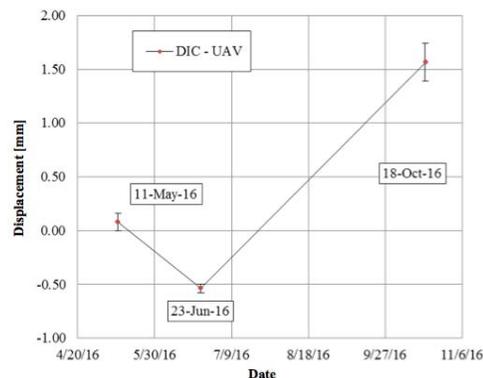
Figure 7. Averaged extensometer displacement results from multiple 3D point tracking measurements. Monitoring period May 11, 2016 to October 18, 2016.

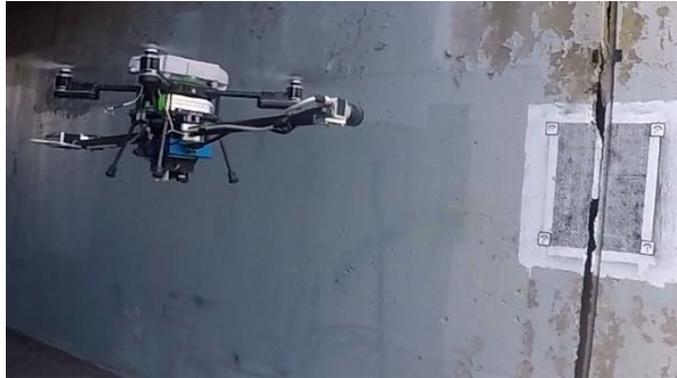
Figure 8. UAV inspection being performed at the expansion joint on the bridge’s right abutment wall on June 23, 2016.

The second area investigated is located on the right side of the bridge as shown in Figure 4, nearly 2 meters away from the road level. Due to the accessibility of this location, a total of nine inspections were performed over a period of 285 days. Three of the inspections utilized the UAV (as shown in Figure 8) while the additional six were performed with the payload being held by an inspector and powered by an external battery pack. As usual, for each of the measurements performed included five snapshots that were taken and results averaged. To further validate the accuracy of the measurements performed using the proposed 3D-DIC system, a back-to-back comparison with measurements acquired

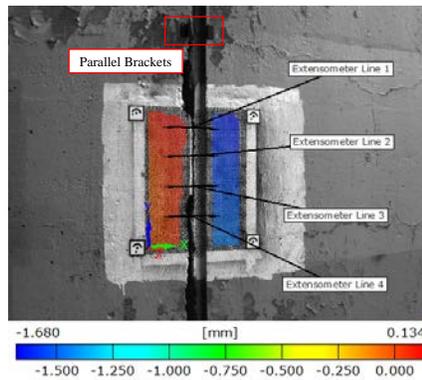
Figure 9. Full-field X-displacement (horizontal) contour plot and extensometer locations across the expansion joint. Monitoring period January 7, 2016 to October 18, 2016.

from parallel brackets fixed to the surface using a 0.001in. graduation dial caliper has been performed and compared to the discrete displacements recorded from the UAV inspections. Figure 9 shows the portion of the joint investigated with the extensometer lines used for calculating the relative motion of the two edges. It should be noticed that the parallel brackets were placed nearly 0.3 m away from the upper edge of the target area shown in Figure 9.

For the long-term monitoring of this expansion joint area, full-field data were generated. When full-field data are collected, any pair of points may be selected to create an optical extensometer. Figure 9 also shows the full-field in-plane X-displacement of the two edges of the crack. As can be observed, the right side of the joint is moving to the left (i.e. negative displacements in the scale bar plotted), while the left side of the crack has little to no movement (i.e. slightly positive displacements in the scale bar plotted). Overall, the crack width is contracting. For this reason, the same area has been monitored for nearly 10 months to determine the ability of the proposed 3D-DIC UAV system in characterizing the activity of the joint over time. Figure 10 shows the change in the length of the four considered extensometer lines over time and the associated error evaluated as the average of the five images recorded in each measurement. The monitoring period to which the plot refers to has been performed between January, 7th and October, 18th 2016. The results show that the crack tends to contract through the whole winter period and the spring, while an opposite trend is shown in the warmest months. The average difference between the displacements measured using 3D-DIC and what was measured with dial calipers is 0.17 mm (relative error = 17.12 %). However it is also noted that this difference is on the same order of magnitude of the accuracy characterizing visual inspection (i.e. 10^{-4} m); thus, the measurement system is still highly capable of achieving a level of accuracy relevant to infrastructure monitoring.

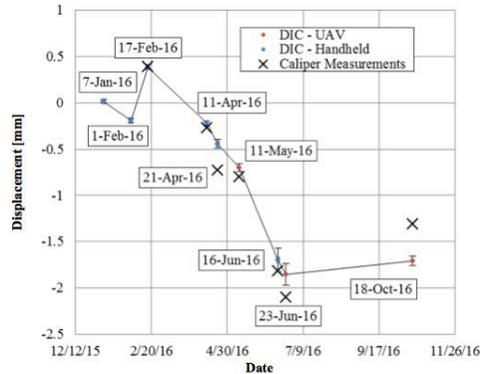
Figure 10. Averaged extensometer displacement results from 3D DIC measurements and comparison with caliper measurements. Monitoring period January 7, 2016 to October 18, 2016.
